Report Number 2517

Evaluation of the High Sea State
Container Transfer System (HISEACOTS)
and Pontoon Air Cushion Kit (PACK)
Technology Demonstration During Joint
Logistics Over-the-Shore (J-LOTS III-91)

April 1992

Analysis of HISEACOTS Ramp-Joint Failure

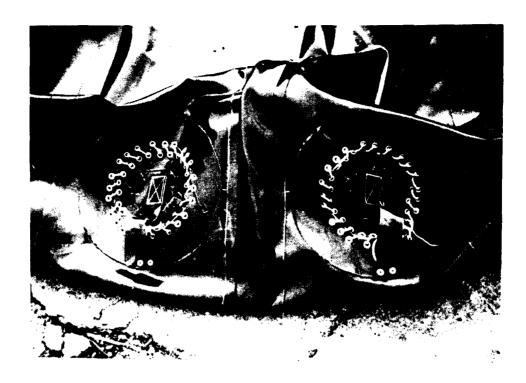
Photo 35

On 26 September, the PACK was towed back to Fort Eustis by a Small Tug for disassembly. The PACK's skirt drain patches were used to help drain water that was caught in the corner bag segments while the PACK was lifted from the water (Photo 35).

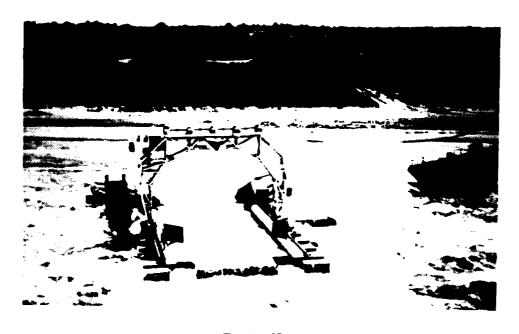
Photo 68

Because the platform, now pivoting on one fender, could damage the T-ACS rudder and propeller, the HISEACOTS was cut loose to ground itself off the beach at Fort Story (Photo 68). A large portion of the platform modules' structural damage was caused by the Army Large Tug continually striking the platform as it attempted to retrieve a line to pull the HISEACOTS away from the side of the T-ACS ship (Photo 69). The HISEACOTS was towed back to the 3rd port at Fort Eustis, VA, on 24 September.
